**Flood Control Project Maintenance
Levee Inspections**

Fall 2013 Levee Maintenance Deficiency Summary Report

Sacramento River Basin

Reclamation District No. 0551 Pearson

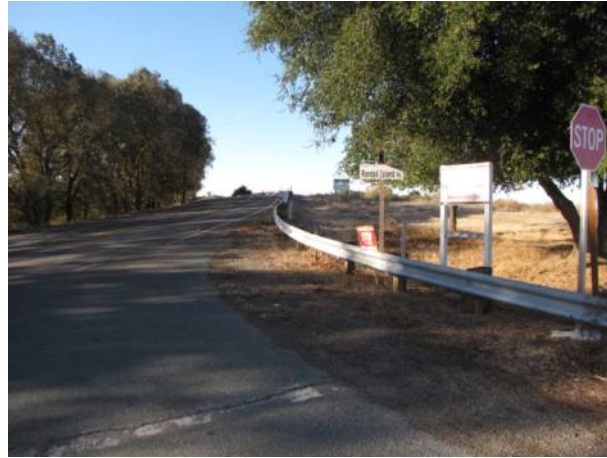
Levee Mile Report Line	4
Start Levee Mile	0.00
End Levee Mile	0.00
Location	Water Side
Category	Earthen Levee
Item	Vegetation

RD 551 levee mile 0.00 looking downstream from waterside slope. Photo taken 11-22-2013.

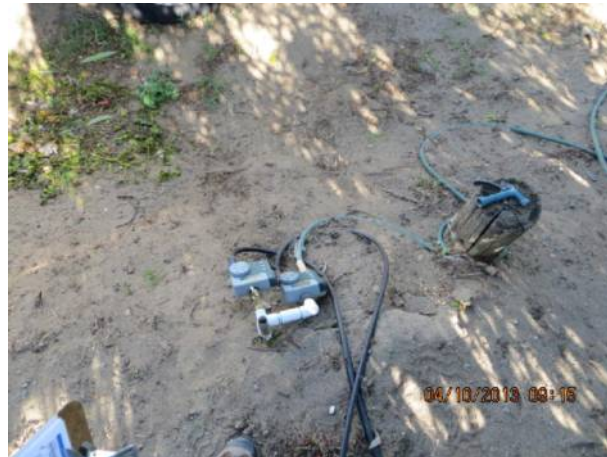
Levee Mile Report Line	6
Start Levee Mile	0.41
End Levee Mile	0.41
Location	Water Side
Category	Supplemental
Item	DWR UCIP Field Study

Irrigation pipes on WS slope.

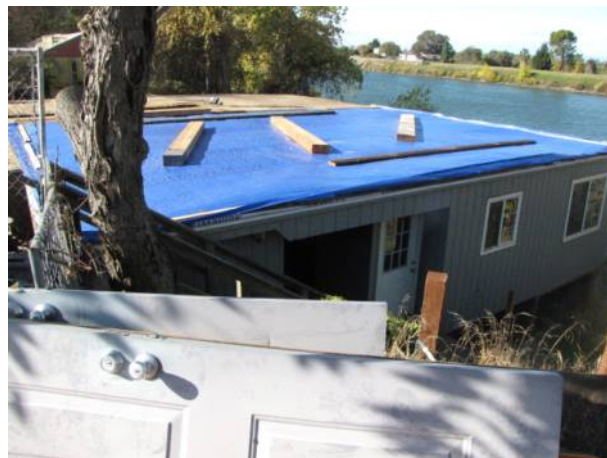
Levee Mile Report Line	7
Start Levee Mile	0.50
End Levee Mile	0.50
Location	Water Side
Category	Earthen Levee
Item	Encroachments

DWR ID: DWR_RD0551_01_f_2013_2										
7	0.50	0.50	Earthen Levee	Encroachments	WS	U En	BU : Building Inspector Comments: There is no CVFPB permit for this construction site. District is aware of the construction, construction has been shut down and landowner is processing application for CVFPB Permit. No new information 11-22-2013.	38.331023 ° -121.570778 °	38.331023 ° -121.570778 °	1 Y
DWR ID: DWR_RD0551_01_f_2012_1										
8	0.60	0.60	Earthen Levee	Encroachments	WS	M En	BU : Building Inspector Comments: There is a metal storage building placed within the 10-foot easement. The land owner has applied for permit to keep it at this location. 3-2013 Spring Inspection: This metal building has been at this location for many years. The original landowner has sold the property to someone else who wishes to retain the building.	38.329918 ° -121.571742 °	38.329918 ° -121.571742 °	9
DWR ID: DWR_RD0551_01_s_2012_9

RD 551 levee mile 0.49 unauthorized building construction waterside of levee section. Photo taken 11-08-2012. During the inspection of 11-22-2013, there hasn't been issued a Permit for this encroachment. No new photo was taken.

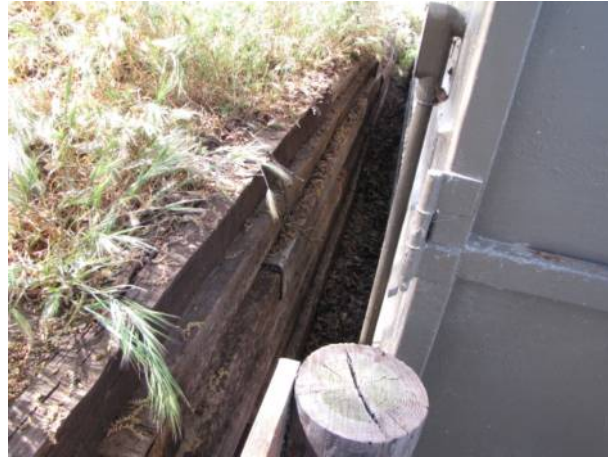
Levee Mile Report Line	9
Start Levee Mile	0.60
End Levee Mile	0.60
Location	Water Side
Category	Earthen Levee
Item	Encroachments

LMR No.	Levee Mile		Category	Item	Location	Rating	Action/Comment	GPS Latitude/Longitude		Issue No.
	Start	End						Start	End	
9	0.60	0.60	Earthen Levee	Encroachments	WS	M En	RW : Retaining Wall Inspector Comments: At this location the new land owner has placed a railroad tie retaining wall against the bank adjacent to the metal building. Discovered during the spring inspection. 3-27-2013. District is working with landowner to get CVFPB permit. No new information 11-2013.	38.329895 ° -121.571840 °	38.329895 ° -121.571840 °	87 Y
DWR ID: DWR_RD0551_01_s_2012_87										
10	0.72	0.72	Supplemental	DWR UCIP Field Study	WS	M En	Inspector Comments: FS_ID:11726 EP_NO: 6220 Repair Type: Non-Urgent Crossing Status: Found UCIP Comments: Pipe abandoned and should be removed. FIELD_STRUCT_DESC: 8-inch steel irrigation pipe through the levee 6.1-feet below the crown. Pump on waterside with slide gate and air vent. (Permit No. 6220, 1968) FS Date: 4/10/2013	38.328401 ° -121.572954 °	38.328401 ° -121.572954 °	4 Y

Here is a picture of the railroad tie retaining wall. Photo taken 3-27-2013. No new photo taken 11-22-2013.

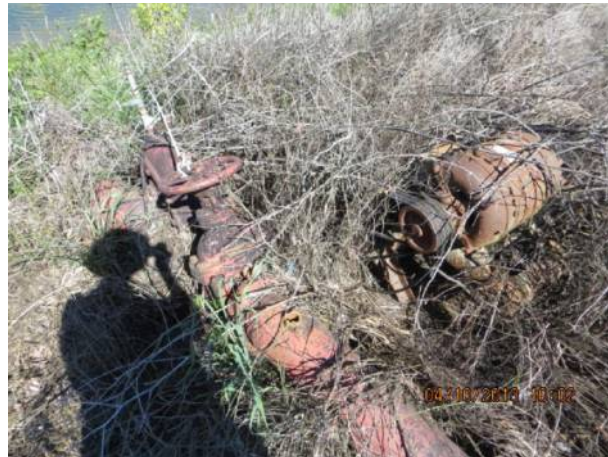
Levee Mile Report Line	10
Start Levee Mile	0.72
End Levee Mile	0.72
Location	Water Side
Category	Supplemental
Item	DWR UCIP Field Study

Pump, slide gate, and missing vent pipe on WS slope.

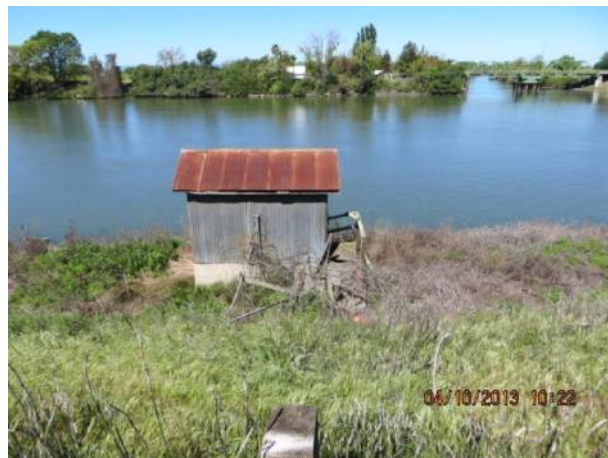
Levee Mile Report Line	11
Start Levee Mile	0.90
End Levee Mile	0.90
Location	Water Side
Category	Supplemental
Item	DWR UCIP Field Study

DWR ID: DWR_RD0551_01_f_2013_4										
11	0.90	0.90	Supplemental	DWR UCIP Field Study	WS	M En	Inspector Comments: FS_ID:11727 EP_NO: 701 Repair Type: Non-Urgent Crossing Status: Found UCIP Comments: Pipe appears abandoned and should be done so properly. Good candidate for video inspection. FIELD_STRUCT_DESC: 14-inch steel irrigation pipe through the levee, 7.2 feet below crown. Pump in pump house on waterward slope. Service pole on landward slope. (Permit No. 701-Smith). 1-inch galvanized filler pipe and a 2-inch electrical conduit at same location. Originally included in O+M manual (1959). FS Date: 4/10/2013	38.326088 ° -121.574525 °	38.326088 ° -121.574525 °	5 Y
DWR ID: DWR_RD0551_01_f_2013_5										
12	1.54	1.62	Earthen Levee	Vegetation	WS	M En	V6 : Landscaping	38.317138 ° -121.576567 °	38.316060 ° -121.576688 °	6
DWR ID: DWR_RD0551_01_s_2012_6										
13	1.57	1.57	Earthen Levee	Encroachments	WS	C En	PO : Pole Inspector Comments: SMUD power pole. Pending contacting SMUD by RD for permit. 4-2013.	38.316695 ° -121.576669 °	38.316695 ° -121.576669 °	86

Pump house and pipes visible on WS slope.

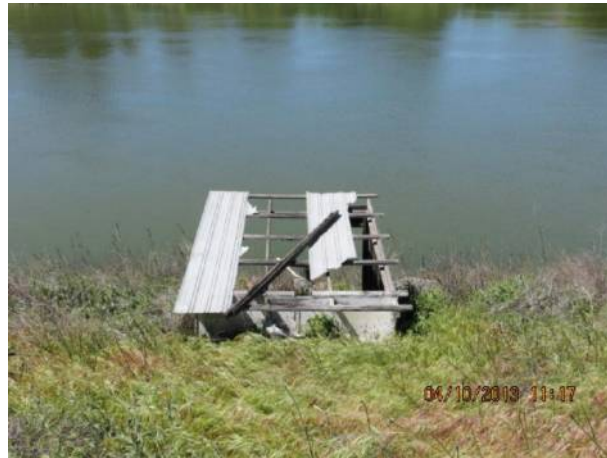
Levee Mile Report Line	16
Start Levee Mile	1.79
End Levee Mile	1.79
Location	Water Side
Category	Supplemental
Item	DWR UCIP Field Study

LMR No.	Levee Mile		Category	Item	Location * + Rating	Action/Comment	GPS Latitude/Longitude		Issue No. Photo
	Start	End					Start	End	
16	1.79	1.79	Supplemental	DWR UCIP Field Study	LS U En	Inspector Comments: FS_ID:11748 EP_NO: 11145 Repair Type: Urgent Crossing Status: Found UCIP Comments: Pipe failing on LS slope causing erosion along pipe alignment. Pipe debris on both slopes should be removed as well. FIELD_STRUCT_DESC: 10-inch pipe through levee, 4.7 feet below crown. Pump in 7'X9' concrete pump house on waterward slope. 36-inch concrete riser on LS toe. 1-inch electrical conduit at same location. Service pole at landward toe (ABO No. 11145-Towne). Originally included in O+M manual (1959). FS Date: 4/10/2013	38.313552 ° -121.576640 °	38.313552 ° -121.576640 °	7 Y
DWR ID: DWR_RD0551_01_f_2013_7									
17	2.03	2.03	Supplemental	DWR UCIP Field Study	LS M En	Inspector Comments: FS_ID:11749 EP_NO: 3676 Repair Type: Non-Urgent Crossing Status: Not Found UCIP Comments: Fresh cut through pavement on crown indicates recent work on pipes at this location. Need to determine if pipe was removed or abandoned in place. FIELD_STRUCT_DESC: 2 of 2: 8-inch steel irrigation pipe sleeved through a 12-inch pipe, 5 feet below crown. Pump on platform waterside. (Permit No. 3676-Wheeler). FS Date: 4/10/2013	38.310237 ° -121.575470 °	38.310237 ° -121.575470 °	8 Y

Pumphouse on WS slope.

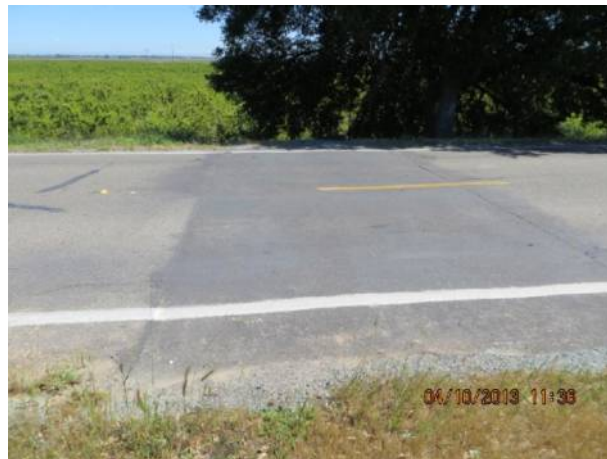
Levee Mile Report Line	17
Start Levee Mile	2.03
End Levee Mile	2.03
Location	Water Side
Category	Supplemental
Item	DWR UCIP Field Study

Fresh cut through pavement at crown.

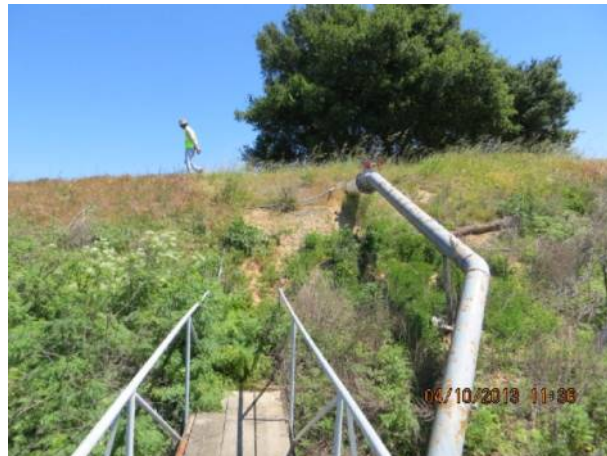
Levee Mile Report Line	18
Start Levee Mile	2.03
End Levee Mile	2.03
Location	Water Side
Category	Supplemental
Item	DWR UCIP Field Study

DWR ID: DWR_RD0551_01_f_2013_8									
18	2.03	2.03	Supplemental	DWR UCIP Field Study	LS M En	Inspector Comments: FS_ID:11763 EP_NO: 6551 Repair Type: Non-Urgent Crossing Status: Found UCIP Comments: Rodent activity undermining pipe on LS slope. FIELD_STRUCT_DESC: 1 of 2: 14-inch PVC wrapped Steel irrigation pipe 3-feet below the crown. Butterfly valve on WS shoulder. 2-inch galvanized electric conduit at same location. Pump on pile structure on WS toe. Pressure booster and pump on LS toe. (Permit No. 6551-Wheeler 1969). FS Date: 4/10/2013	38.310223 ° -121.575458 °	38.310223 ° -121.575458 °	12 Y
DWR ID: DWR_RD0551_01_f_2013_12

Pipe, butterfly valve, and electrical conduit 3-feet below the crown on the WS shoulder.

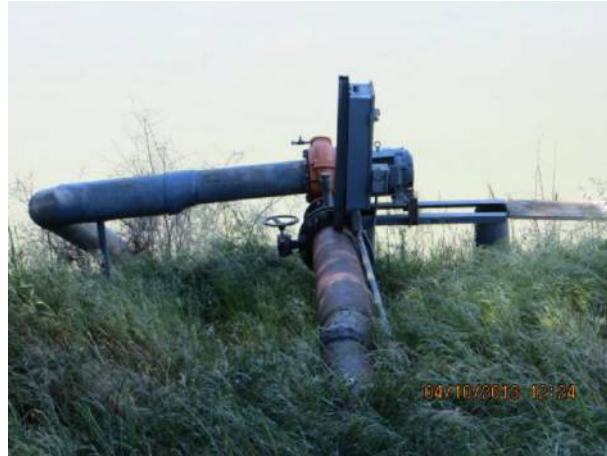
19	2.43	2.43	Supplemental	DWR UCIP Field Study	LS	M En	Inspector Comments: FS_ID:11783 EP_NO: 11141 Repair Type: Non-Urgent Crossing Status: Found UCIP Comments: Records indicate this pipe was abandoned, but it appears to be active. Verify status. FIELD_STRUCT_DESC: 10-inch steel irrigation pipe through levee, 8.0 feet below the crown. Slant pump on waterward slope. Service pole on landward slope with a 1.5-inch galvanized iron electrical conduit through the levee at same location. (ABO No. 11141-Runyon). Originally included in O+M manual (1959). FS Date: 4/10/2013	38.305189 ° -121.572012 °	38.305189 ° -121.572012 °	13 Y
----	------	------	--------------	----------------------	----	---------	--	------------------------------	------------------------------	---------

Levee Mile Report Line	19
Start Levee Mile	2.43
End Levee Mile	2.43
Location	Water Side
Category	Supplemental
Item	DWR UCIP Field Study
Pump, pipe, and butterfly valve on WS slope.	
UCIP_6382.jpg

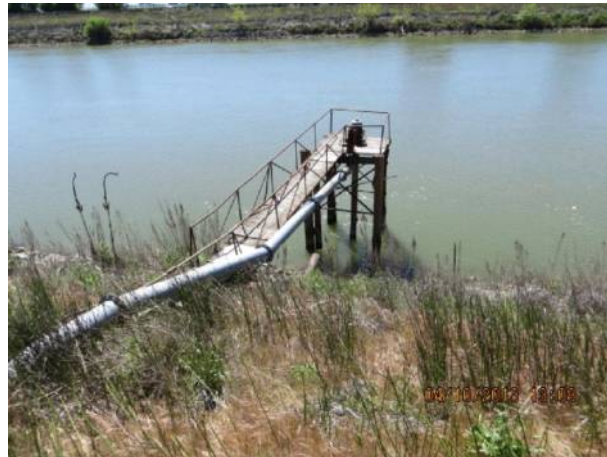
20	2.99	2.99	Supplemental	DWR UCIP Field Study	LS	M En	Inspector Comments: FS_ID:11803 EP_NO: 1204 Repair Type: Non-Urgent Crossing Status: Found UCIP Comments: Gap between sleeved pipes does not appear to be grouted on LS slope. FIELD_STRUCT_DESC: 12-inch steel conduit with 10-inch irrigation pipe sleeved through it 6-feet below the crown. Pump on pile structure on the Water Side toe. 48-inch concrete riser on LS toe. (Permit No. 1204-Wheeler). Originally included in the O+M manual 1959. FS Date: 4/10/2013	38.298323 ° -121.566941 °	38.298323 ° -121.566941 °	14 Y
----	------	------	--------------	----------------------	----	---------	---	------------------------------	------------------------------	---------

Levee Mile Report Line	20
Start Levee Mile	2.99
End Levee Mile	2.99
Location	Water Side
Category	Supplemental
Item	DWR UCIP Field Study
10-inch steel irrigation pipe and steel pump structure on WS toe.	
UCIP_6384.jpg

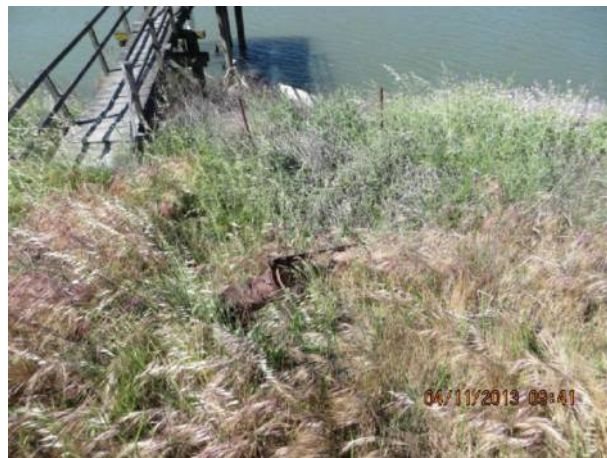
21	4.05	4.05	Supplemental	DWR UCIP Field Study	LS	M En	Inspector Comments: FS_ID:11817 EP_NO: N/A Repair Type: Non-Urgent Crossing Status: Found UCIP Comments: Abandoned. Determine if pipe was removed or abandoned in place. FIELD_STRUCT_DESC: 8-inch irrigation pipe through the levee 6.7-feet below the crown. Abandoned slide gate at pad on WS slope. Originally included in O+M manual 1959. FS Date: 4/11/2013	38.286593 ° -121.554591 °	38.286593 ° -121.554591 °	17 Y
----	------	------	--------------	----------------------	----	---------	--	------------------------------	------------------------------	---------

Levee Mile Report Line	21
Start Levee Mile	4.05
End Levee Mile	4.05
Location	Water Side
Category	Supplemental
Item	DWR UCIP Field Study
Abandoned slide gate on WS slope.	
UCIP_6387.jpg

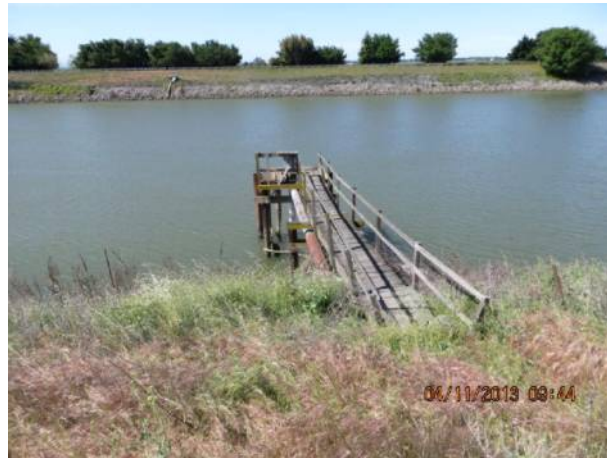
22	4.05	4.05	Supplemental	DWR UCIP Field Study	LS	M En	<p>Inspector Comments: FS_ID:11823 EP_NO: 11146 Repair Type: Non-Urgent Crossing Status: Found UCIP Comments: Wooden walkway in bad repair and presents a hazard to the public. FIELD_STRUCT_DESC: 14-inch pipe through levee, 10.4 feet below crown. Pump on pile structure in stream with wooden walkway. 48-inch concrete standpipe on LS toe with booster pump and electric panel. Siphon breaker in 24-inch CMP riser on LS slope. 1.5-inch electrical conduit at same location.(ABO No. 11146- Turner). Originally included in O+M manual 1959. FS Date: 4/11/2013</p>	38.286568 ° -121.554569 °	38.286568 ° -121.554569 °	18 Y
----	------	------	--------------	----------------------	----	---------	--	------------------------------	------------------------------	---------

Levee Mile Report Line	22
Start Levee Mile	4.05
End Levee Mile	4.05
Location	Water Side
Category	Supplemental
Item	DWR UCIP Field Study
<p>Pump on pier with wooden walkway on WS toe.</p> <p>UCIP_6388.jpg</p>

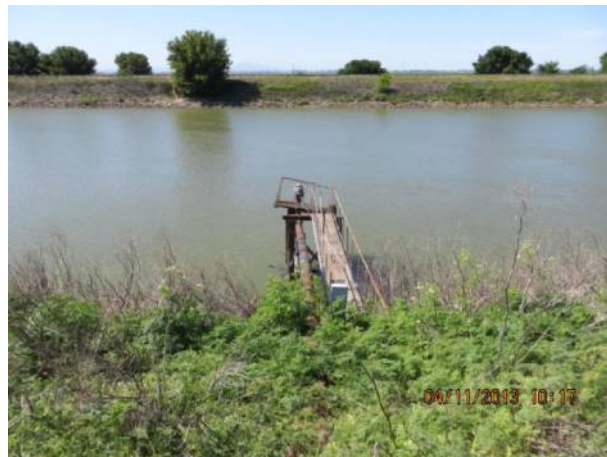
23	4.63	4.63	Supplemental	DWR UCIP Field Study	LS	U En	<p>Inspector Comments: FS_ID:11826 EP_NO: 11152 Repair Type: Urgent Crossing Status: Found UCIP Comments: Pier for pump is falling apart and is a hazard to the public. Some settlement along pipe on LS slope. FIELD_STRUCT_DESC: 10-inch steel irrigation pipe through the levee 6.5 feet below the crown. Pump on pile structure in stream. Service pole at landward toe and a 36-inch concrete riser on the LS toe. 1-inch electrical conduit at same location. (ABO No. 11152-Wilcox) Originally included in O+M manual 1959. FS Date: 4/11/2013</p>	38.281074 ° -121.546628 °	38.281074 ° -121.546628 °	19 Y
----	------	------	--------------	----------------------	----	---------	---	------------------------------	------------------------------	---------

Levee Mile Report Line	23
Start Levee Mile	4.63
End Levee Mile	4.63
Location	Water Side
Category	Supplemental
Item	DWR UCIP Field Study
<p>Pump on pier showing structural failure on WS toe.</p> <p>UCIP_6390.jpg</p>

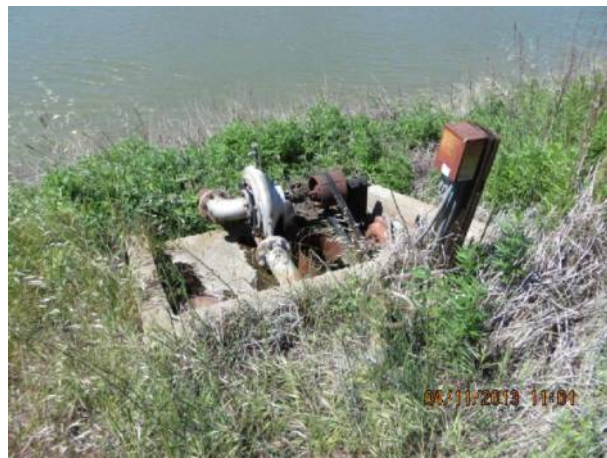
25	5.10	5.10	Supplemental	DWR UCIP Field Study	LS	M En	Inspector Comments: FS_ID:12105 EP_NO: 11125 Repair Type: Non-Urgent Crossing Status: Found UCIP Comments: Pumphouse has been removed from pump and pump is in disrepair. Pipe at LS toe is sleeved or has been replaced with a 6-inch PVC pipe. This pump appears abandoned and should be done so properly. FIELD_STRUCT_DESC: 6-inch pipe through the levee 6.5-feet below the crown. Pump and slide gate on WS slope. 1-inch electrical conduit at same location with service pole at landward toe. 4'X6' concrete distribution box at LS toe (ABO No. 11125- Cortopassi). Originally included in O+M manual 1959. FS Date: 4/11/2013	38.276220 ° -121.540811 °	38.276220 ° -121.540811 °	21 Y
----	------	------	--------------	----------------------	----	---------	--	------------------------------	------------------------------	---------

Levee Mile Report Line	25
Start Levee Mile	5.10
End Levee Mile	5.10
Location	Water Side
Category	Supplemental
Item	DWR UCIP Field Study
<p>Pump and slide gate on concrete pad at WS slope.</p> <p>UCIP_6434.jpg</p>

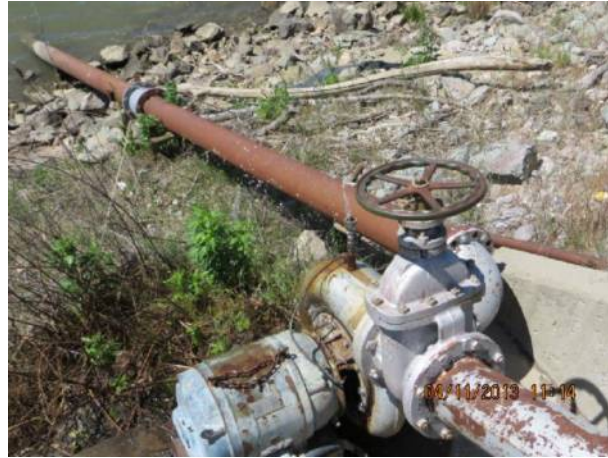
26	5.31	5.31	Supplemental	DWR UCIP Field Study	LS	U En	Inspector Comments: FS_ID:12064 EP_NO: 11131 Repair Type: Urgent Crossing Status: Found UCIP Comments: Corrosion holes in pipe at LS toe good indicator that pipe is failing internally. Pipe should be examined internally for damage (video inspect). FIELD_STRUCT_DESC: 10-inch pipe through the levee 7.7-feet below the crown. Pump and slide gate on concrete pad on waterward slope. Siphon breaker in 24-inch CMP riser on LS slope. Concrete riser, power pole with panel box on landward toe. (ABO No. 11131-Latimer). Originally included in the O+M manual 1959. FS Date: 4/11/2013	38.274147 ° -121.538076 °	38.274147 ° -121.538076 °	22 Y
----	------	------	--------------	----------------------	----	---------	---	------------------------------	------------------------------	---------

Levee Mile Report Line	26
Start Levee Mile	5.31
End Levee Mile	5.31
Location	Water Side
Category	Supplemental
Item	DWR UCIP Field Study
<p>Pump and slide gate at Concrete pad on WS slope.</p> <p>UCIP_6419.jpg</p>
